# Assessment of Dam Safety

## Coal Combustion Surface Impoundments (Task 3)

### Final Report

Progress Energy  
Carolinas  
Cape Fear Plant

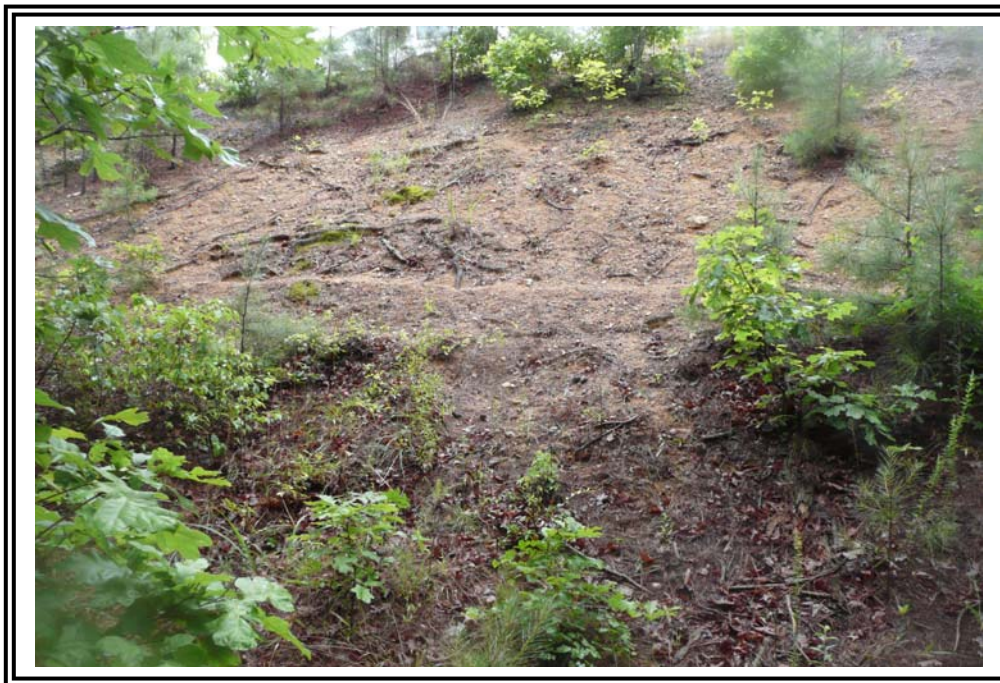
62

Downstream slope at the south end of the 1978 Ash Pond Dike is devoid of vegetation.

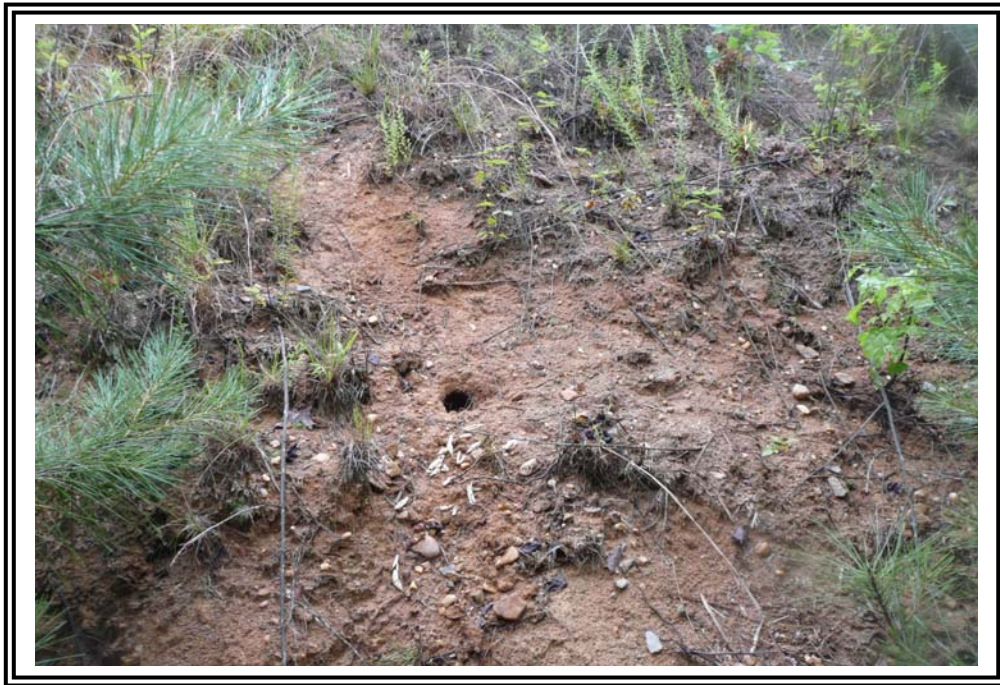
Evidence of soil disturbance from animal activity was observed in a few locations. Photo 52 shows a slide likely resulting from beaver or muskrat activity, and Photo 63 shows an animal burrow.

Evidence of animal burrow at the south end of the 1978 Ash Pond Dike.

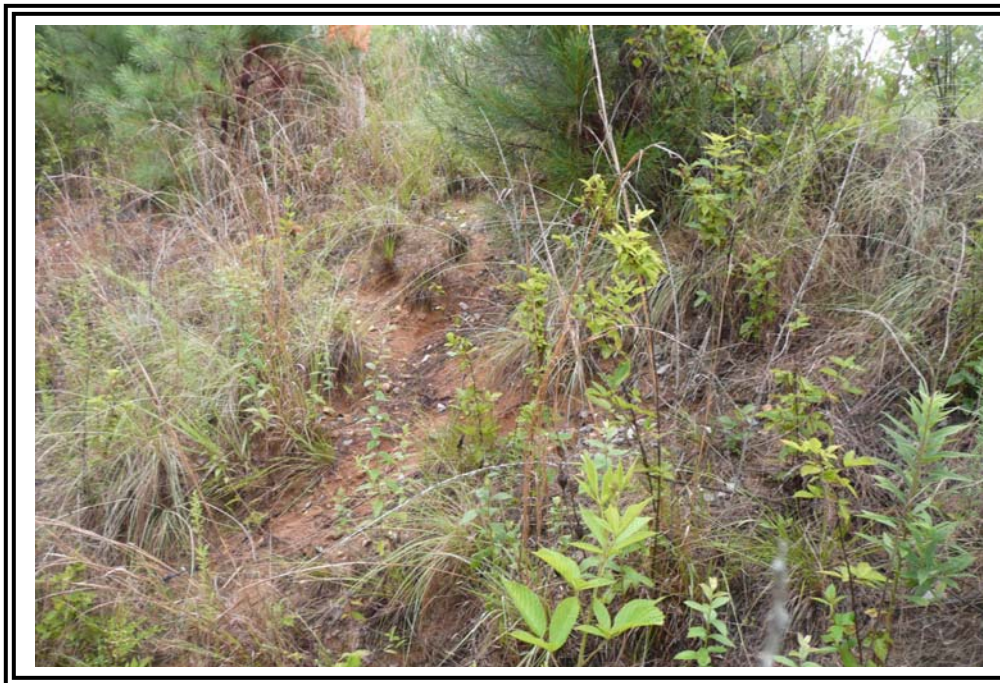
64

Example of erosion around sparse surface vegetation at the south end of the 1978 Pond.

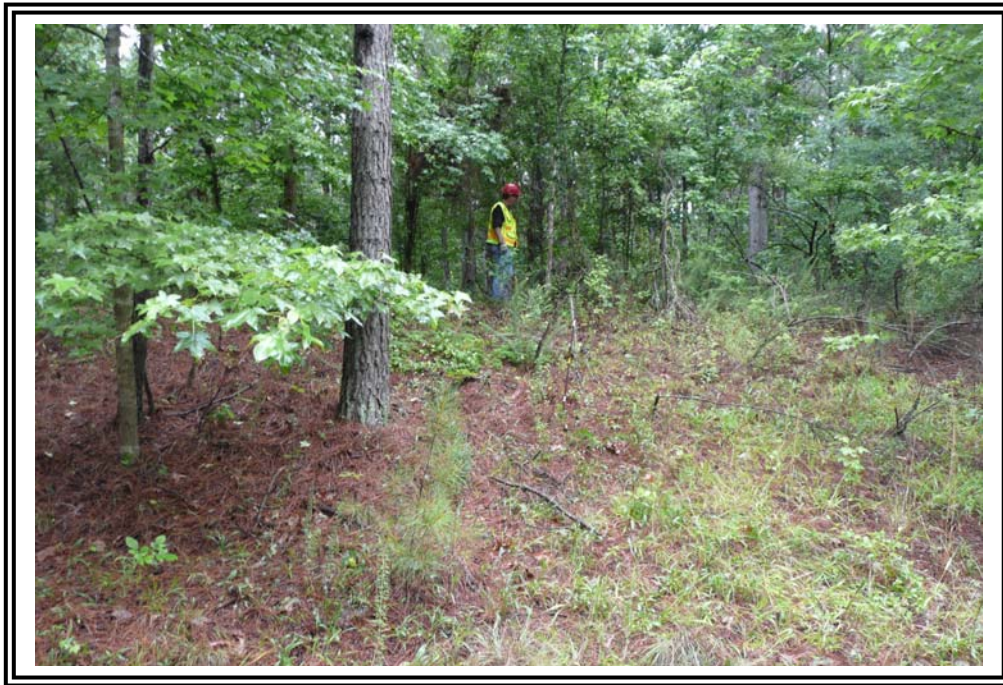
69

1970 Ash Pond east dike downstream slope. Note photographer is standing at the toe of the dike and the person in the photograph is standing at the crest.

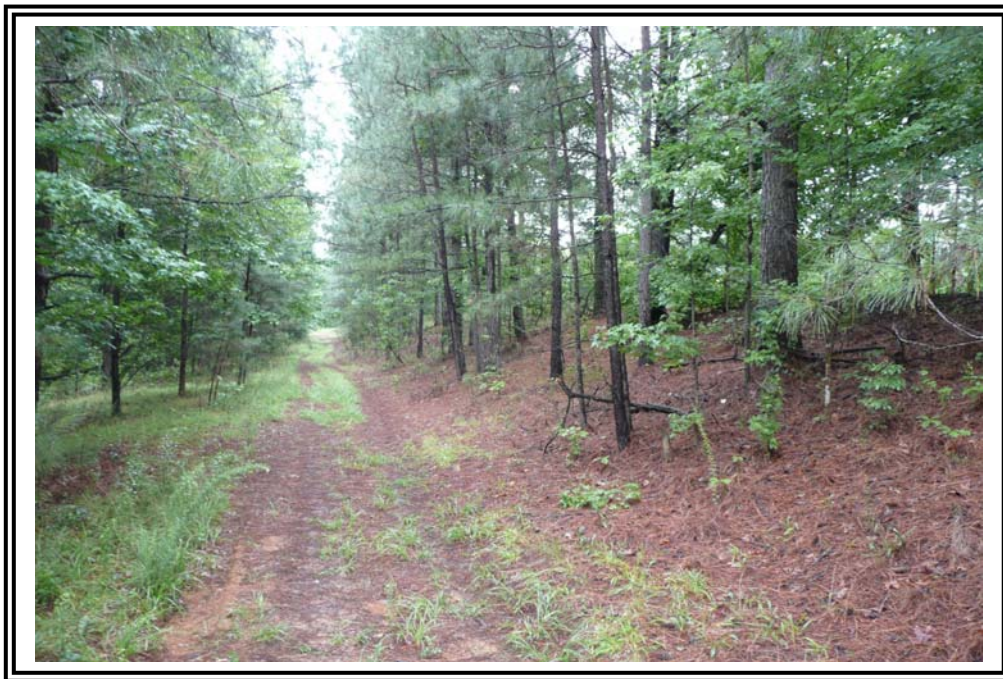
70

1970 Ash Pond east dike toe looking south. Note road runs along toe of dike in this area.

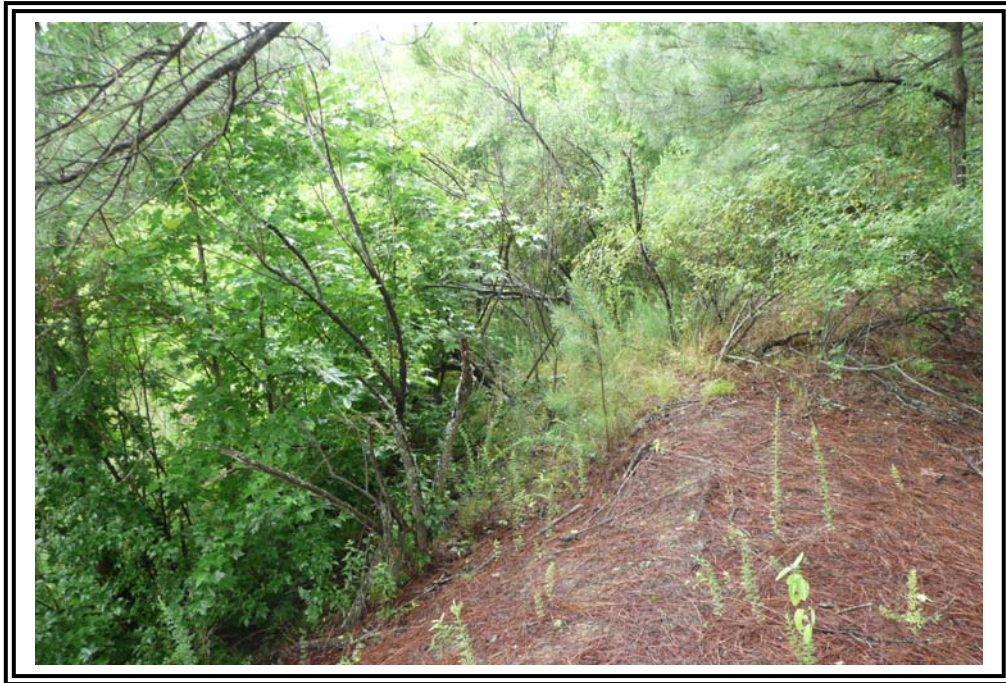
71

Upstream slope of 1970 Ash Pond east dike looking north.

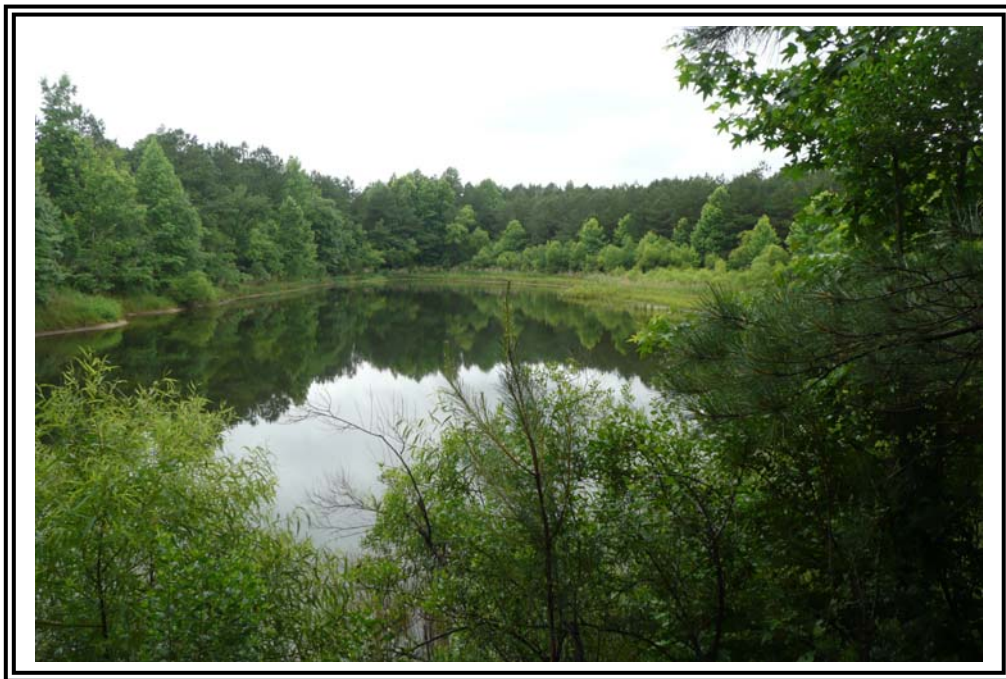
72

Southern portion of 1970 Ash Pond contains water. Looking west from east dike.

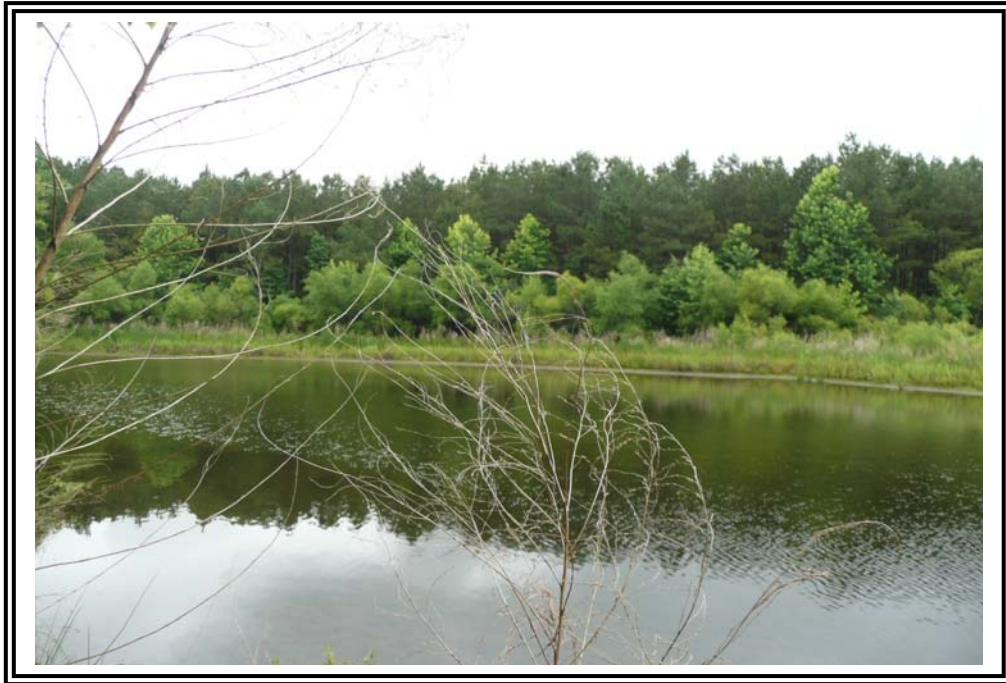
75

1970 Ash Pond looking north across the pond from the south dike.

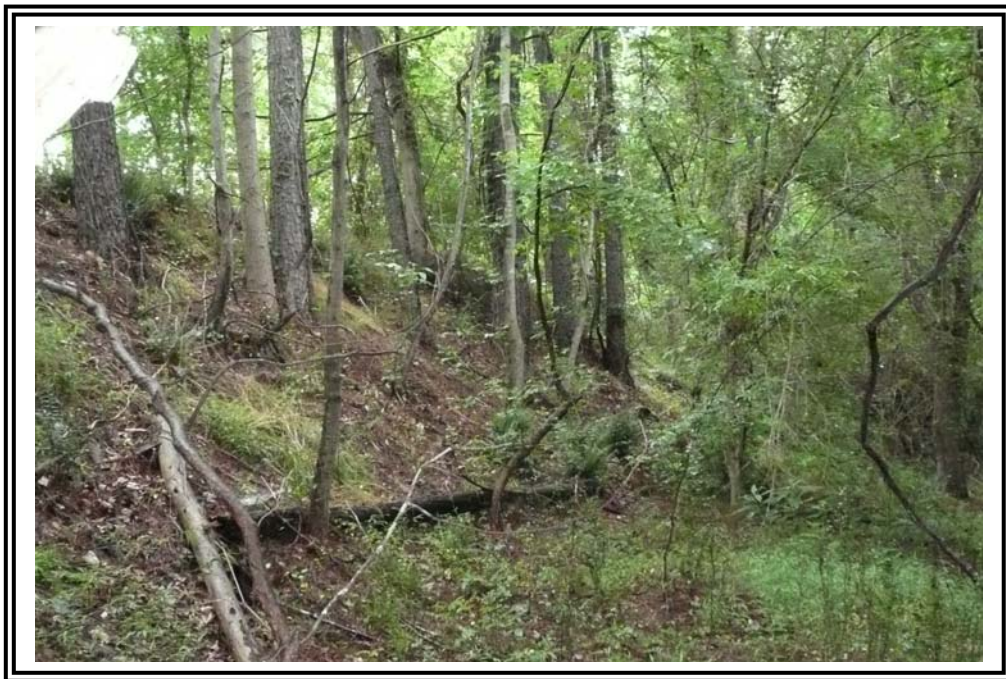
76

1970 Ash Pond downstream slope near southwest corner.

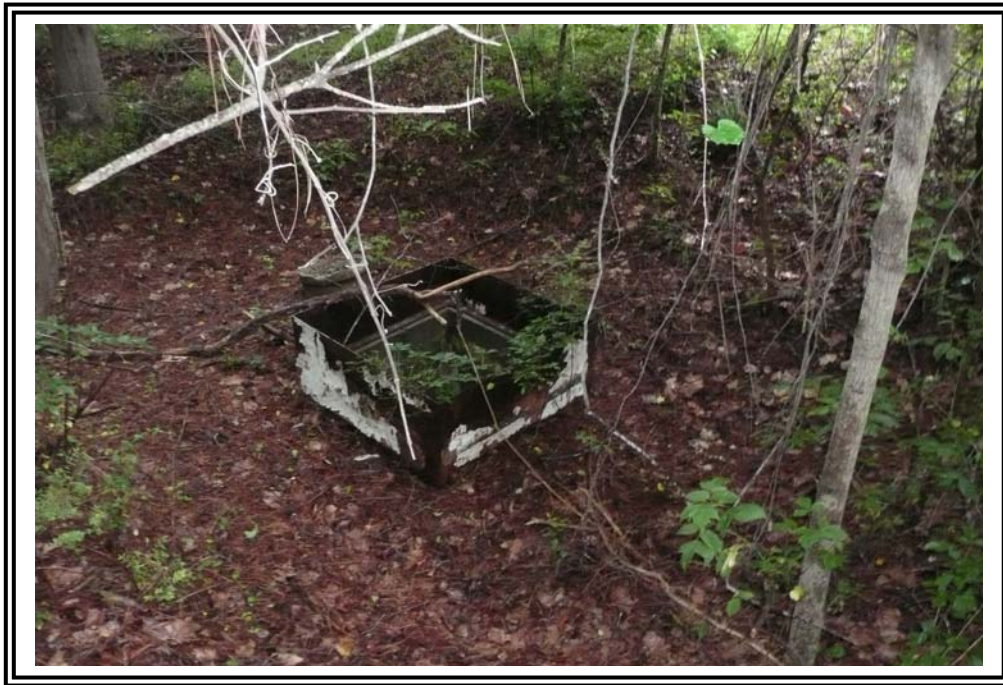
77

1970 Ash Pond outlet control structure. Note: water level in south end of pond was several feet lower than outlet during our visit.

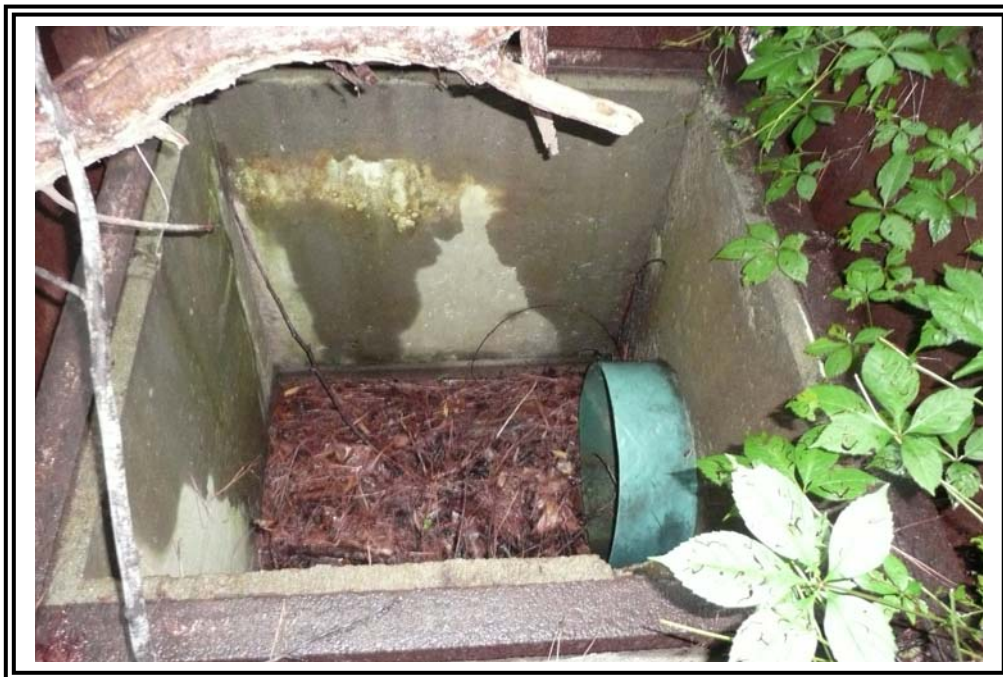
78

Close up of 1970 Ash Pond outlet control structure.

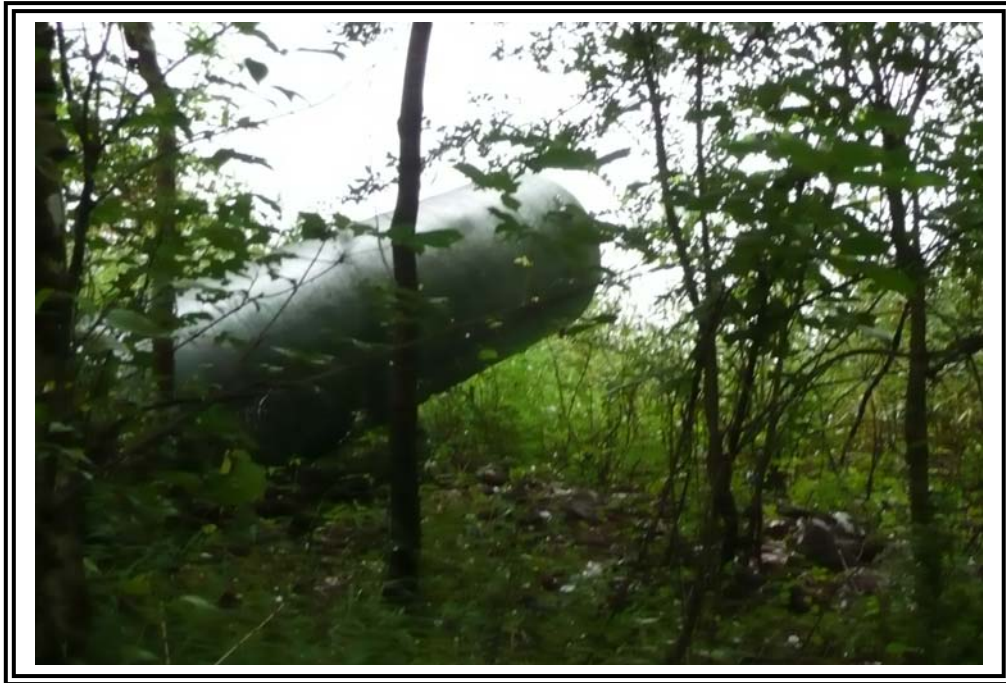
79

Downstream end of 1970 Ash Pond outlet.

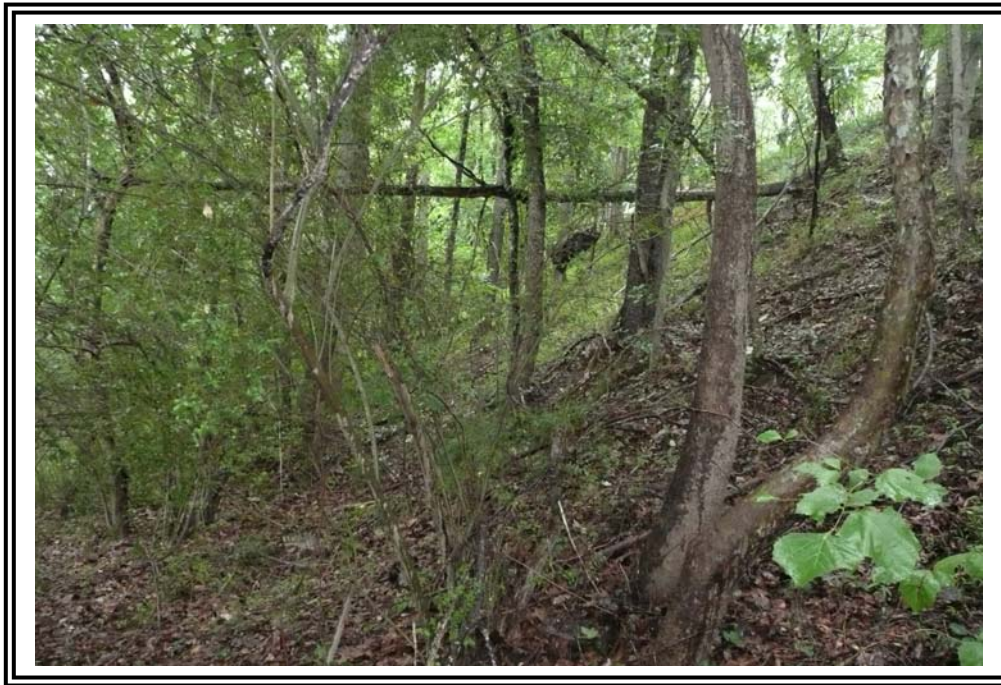
81

Typical condition of 1970 Ash Pond west dike downstream slope (looking north).

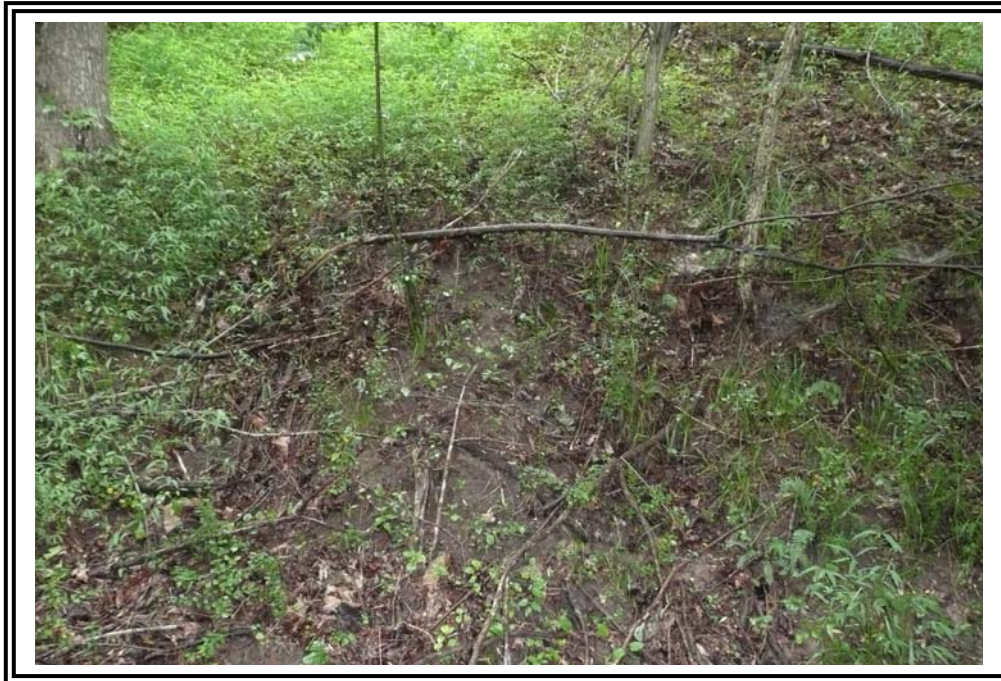
83

Surface erosion on 1970 Ash Pond west dike downstream slope.

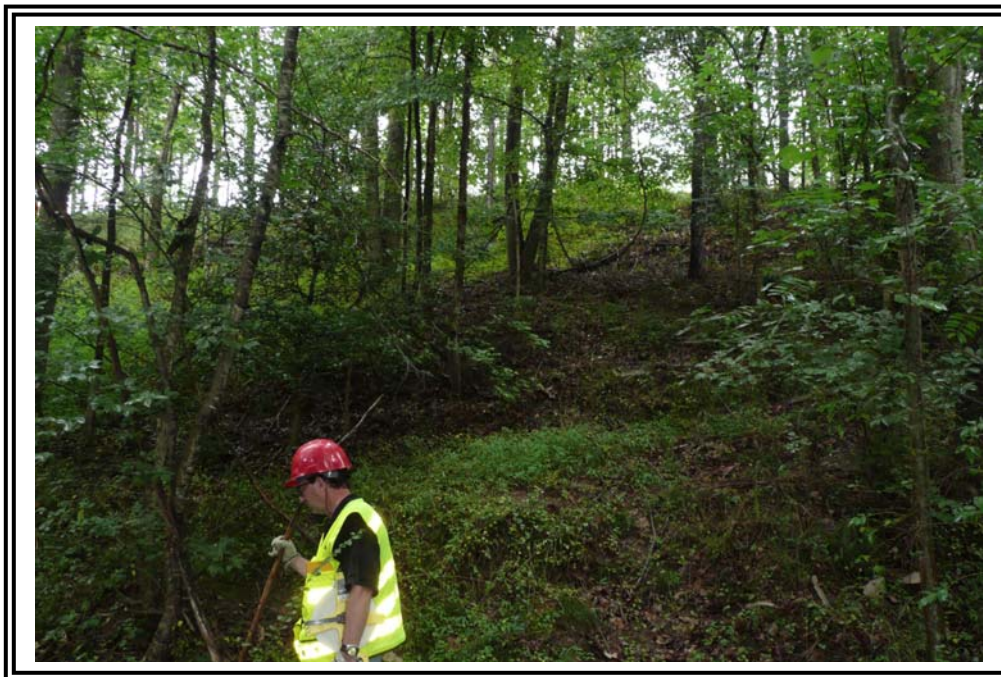
84

Surface erosion and sloughing on 1970 Ash Pond west dike downstream slope.

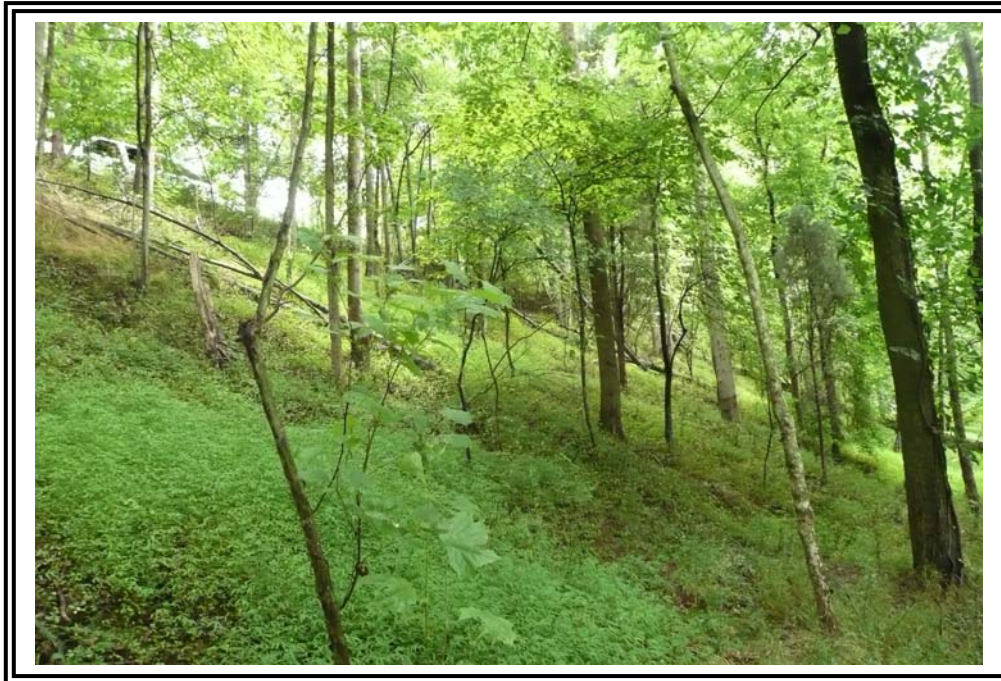
85

Downstream slope of 1963 Ash Pond west dike. Note suburban parked on crest for scale.

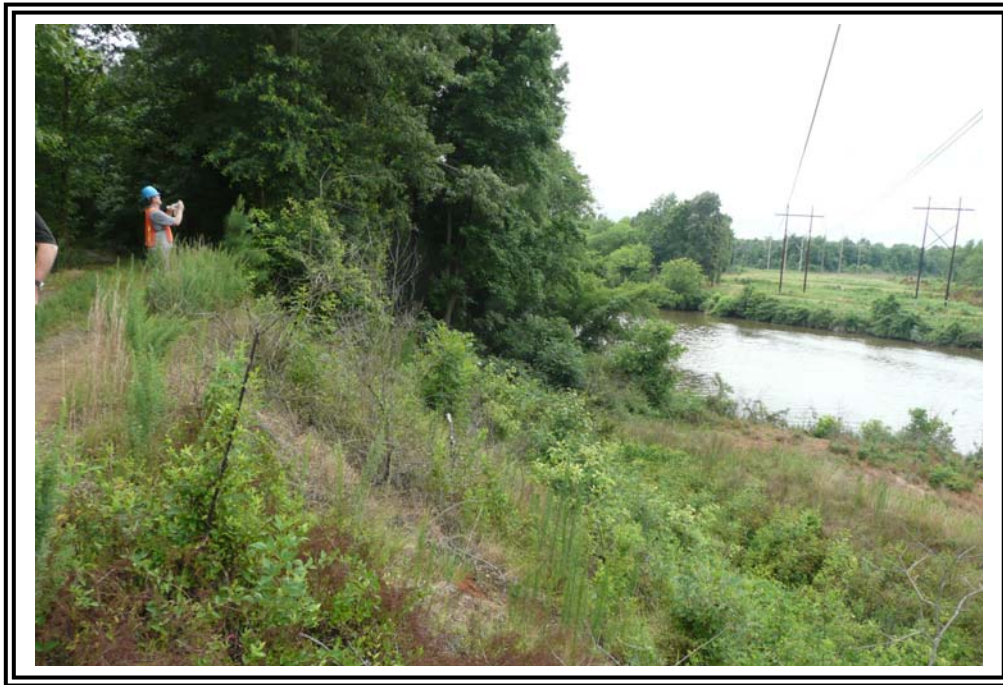
89

North end of 1963 Ash Pond west dike looking south. This is adjacent to the 1982 slide area. Water in background is the Cape Fear River.

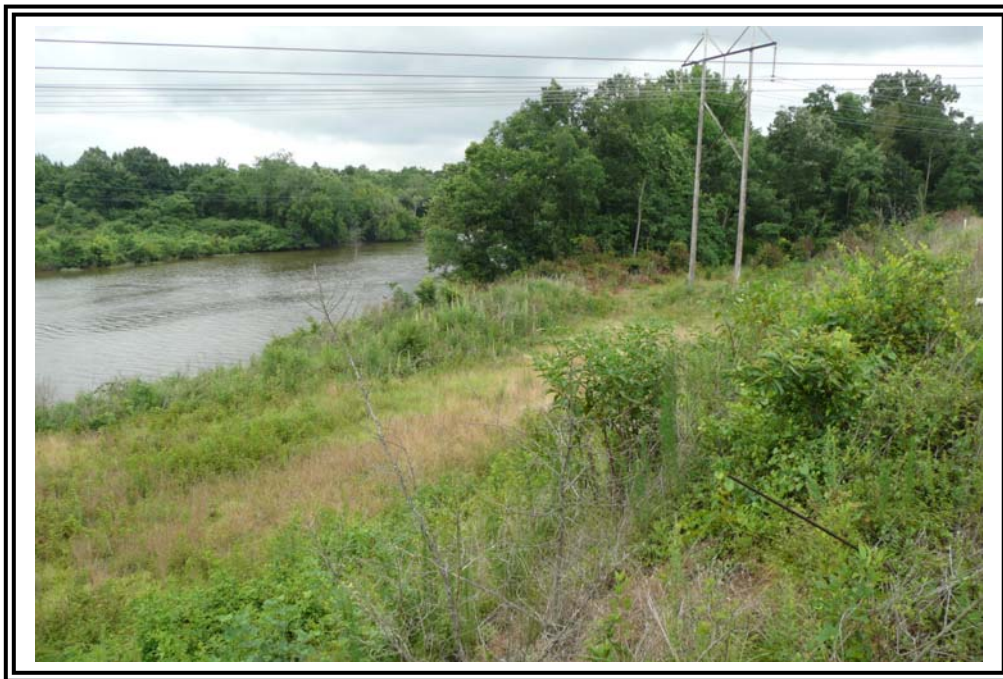
90

North end of 1963 Ash Pond west dike, looking northwest. Water is Cape Fear River.

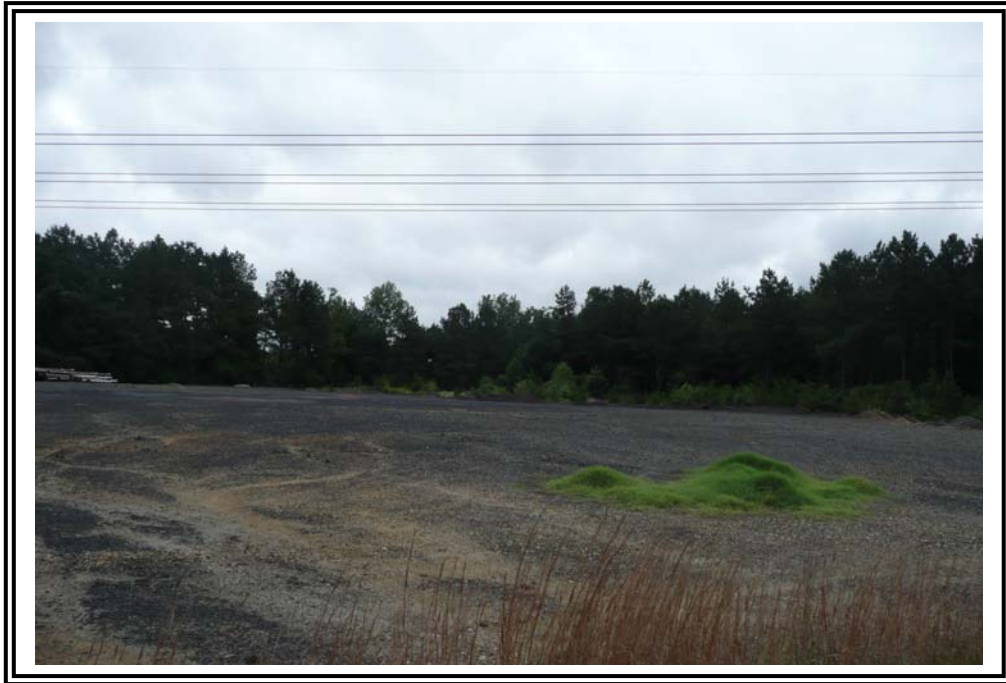
North end of 1963 Ash Pond.

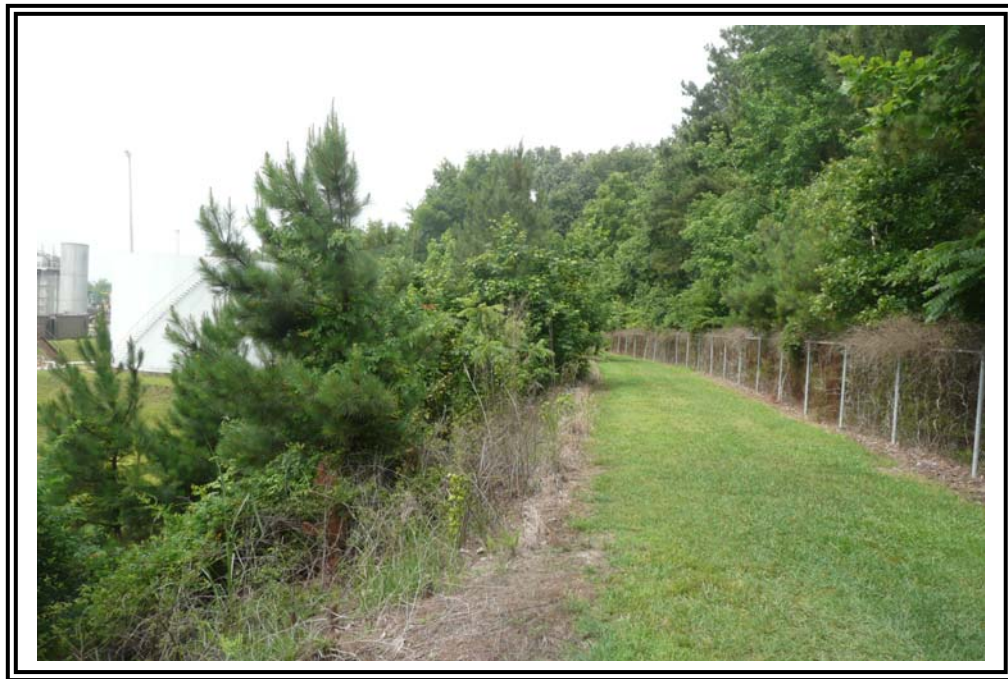
93

Flood control dike which contained the south side of the 1956 Ash Pond, looking southwest.

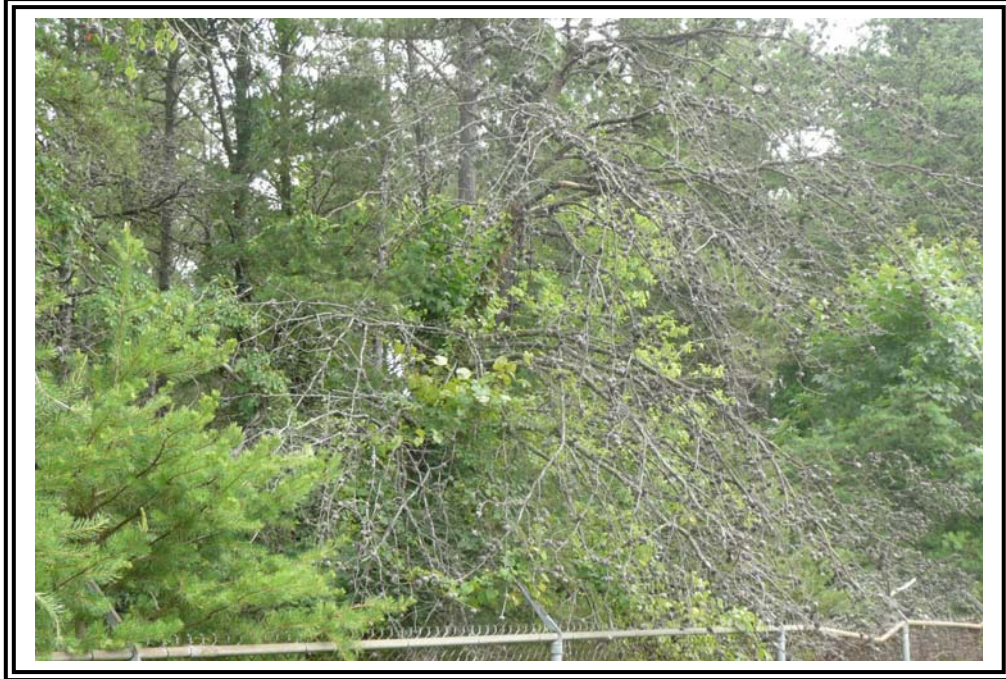
94

1956 Ash Pond from the south Dike, looking north.  
Note: This pond does not contain free water and is overgrown with trees.

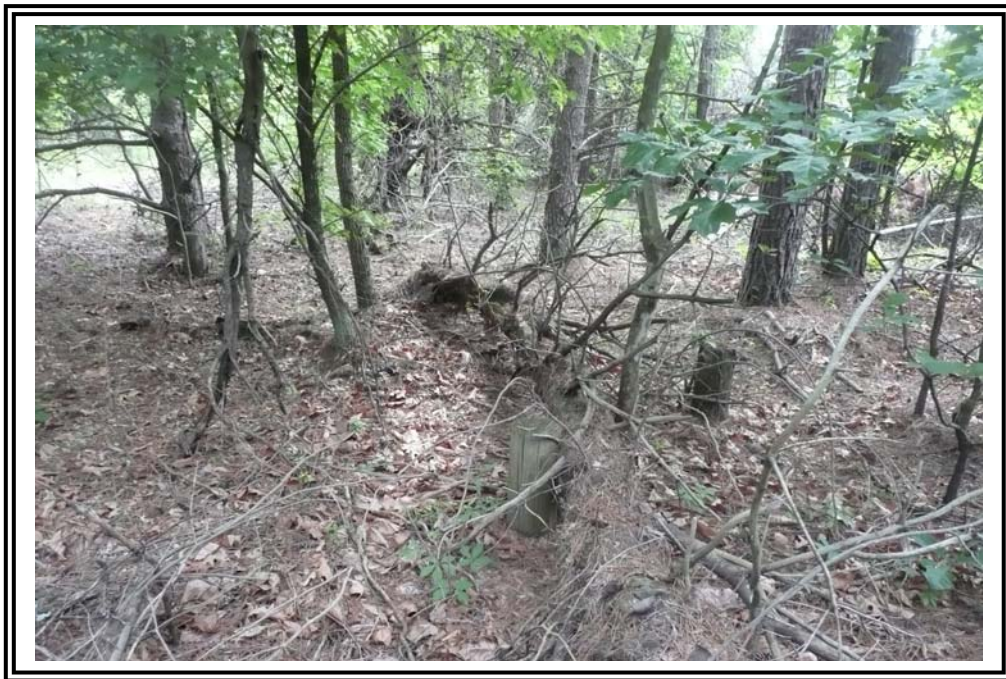
95

Remains of outlet structure at southwest corner of 1956 Ash Pond.

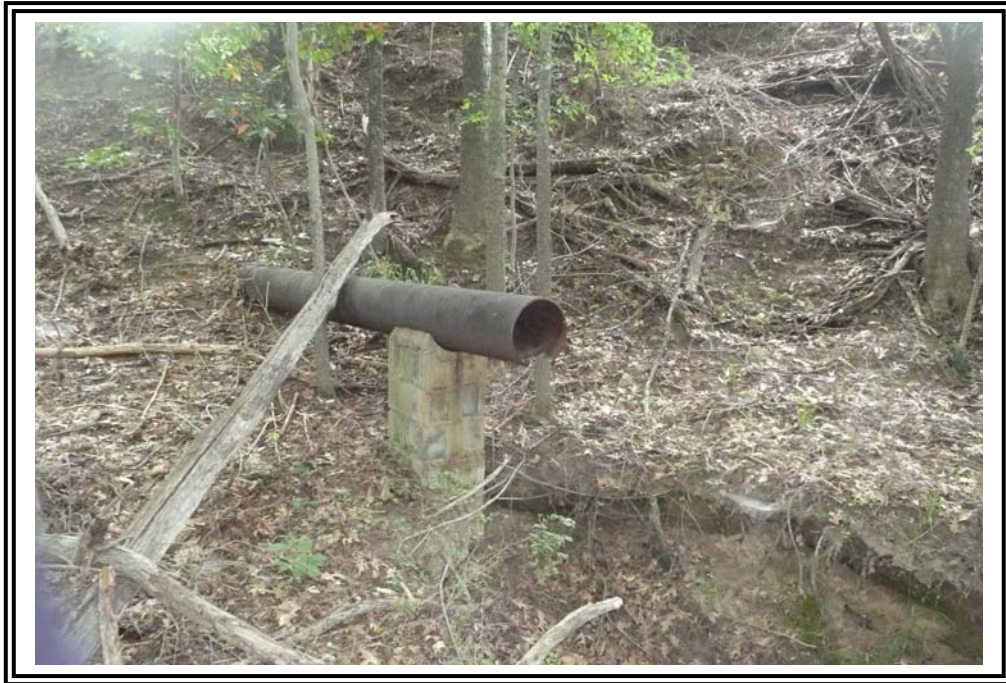
96

Former outlet pipe from 1956 Ash Pond. Pond no longer contains free water.

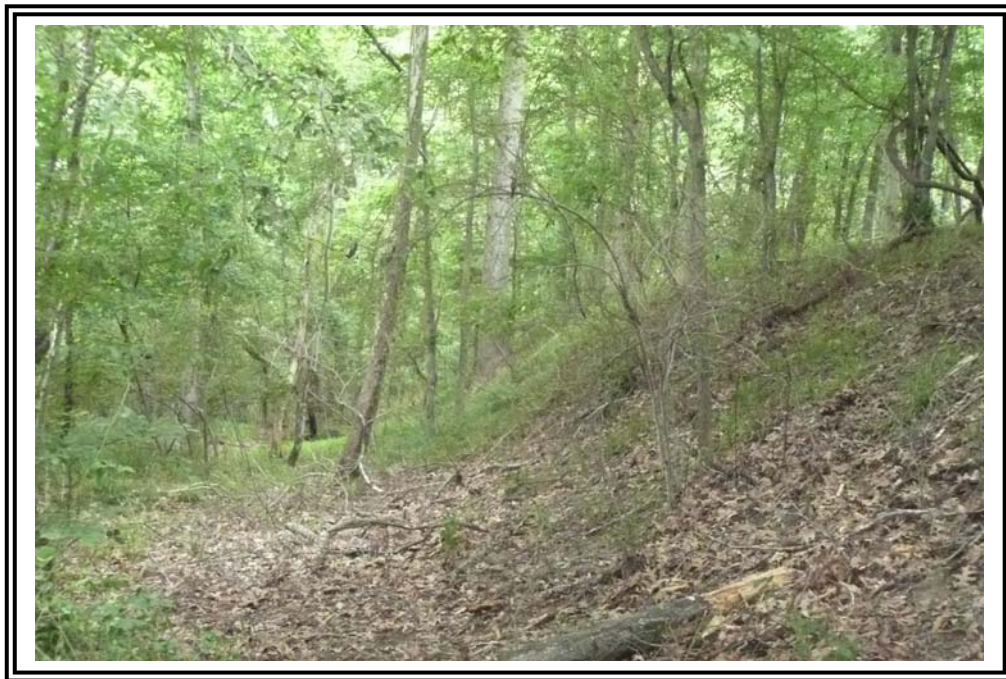
97

Downstream slope of the west Dike, looking north.

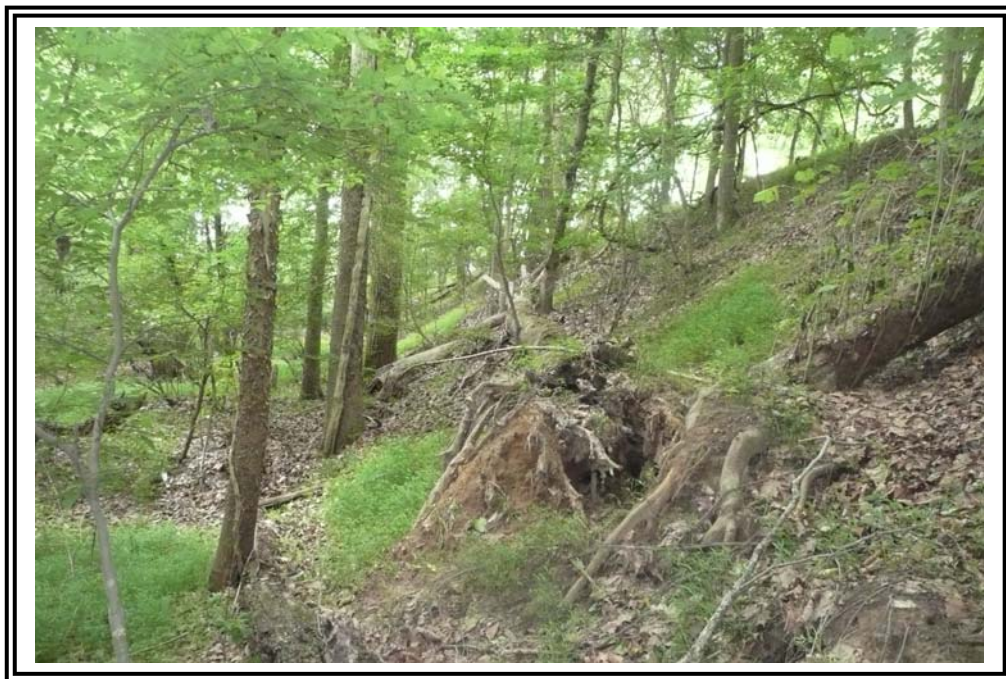
101

Uprooted tree on the 1956 Ash Pond Dike.

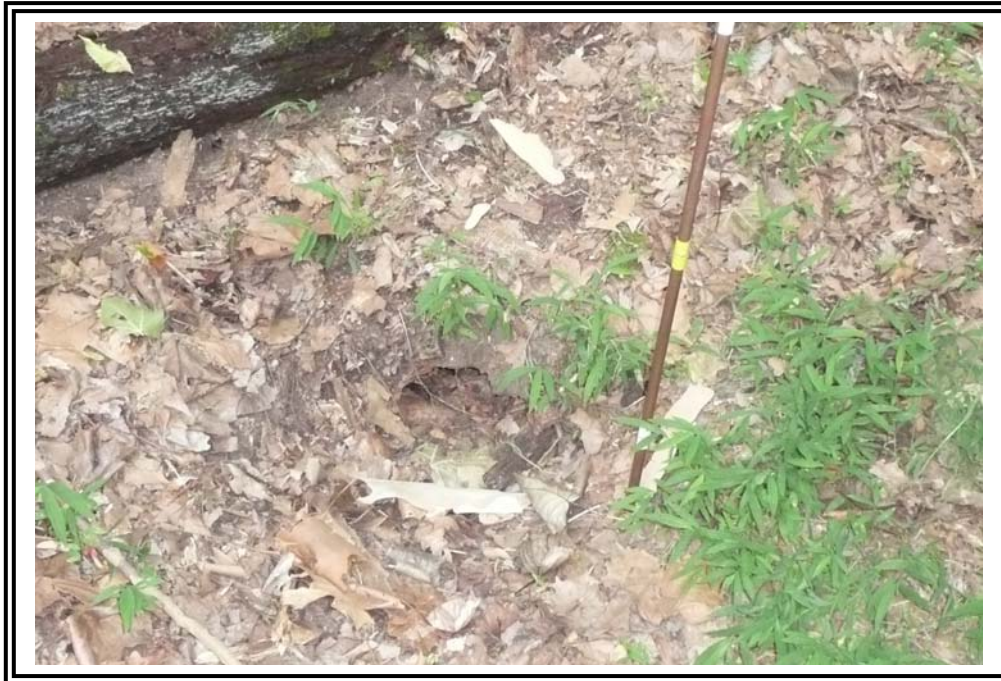
102

Top of probable stormwater outlet pipe on the 1956 Ash Pond Dike.

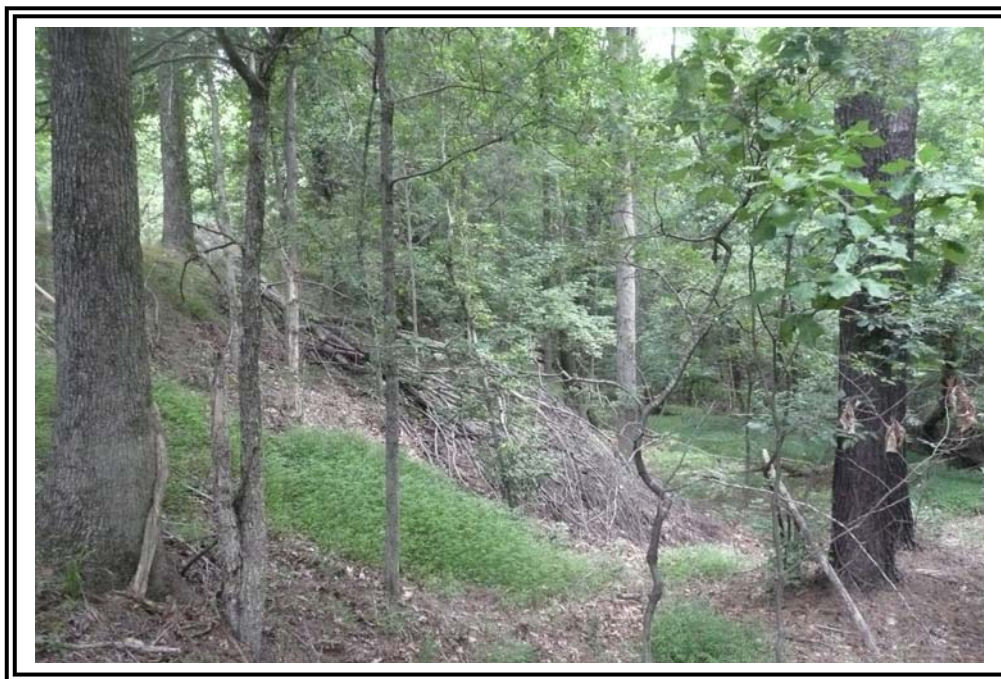
103

Typical slope sloughing and erosion on the 1956 Ash Pond Dikes.

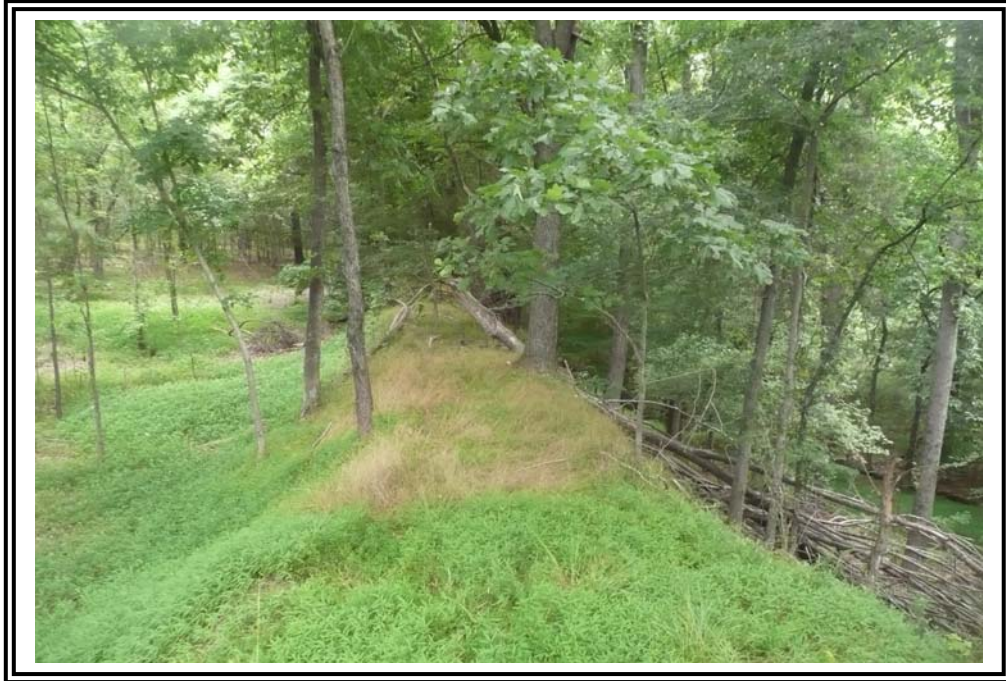
104

Crest of the 1956 Ash Pond Dike.

Note: Some areas of the ash surface inside the pond was approximately equal to the top of the Dike.

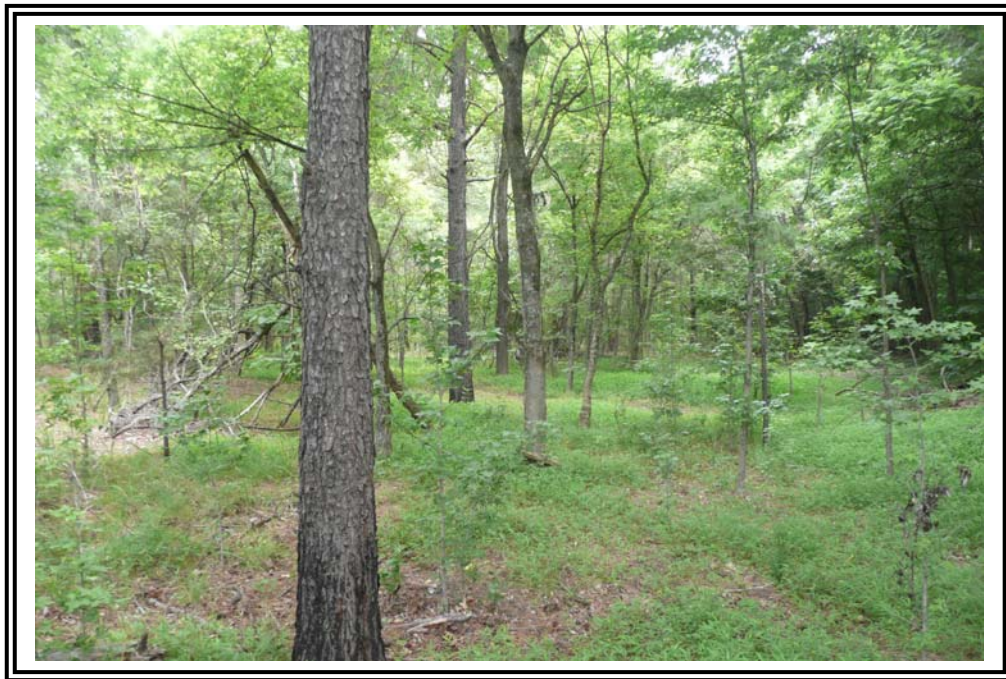
105

Typical forest cover on the 1956 Ash Pond.

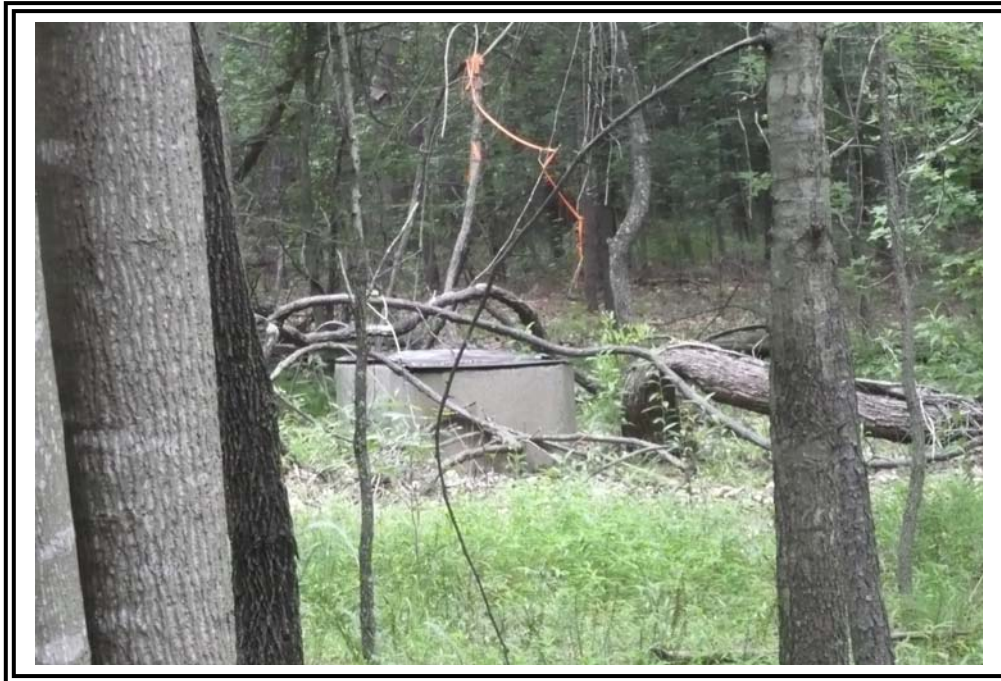
106

Storm water drainage structure at the northeast end of the 1956 Ash Pond.

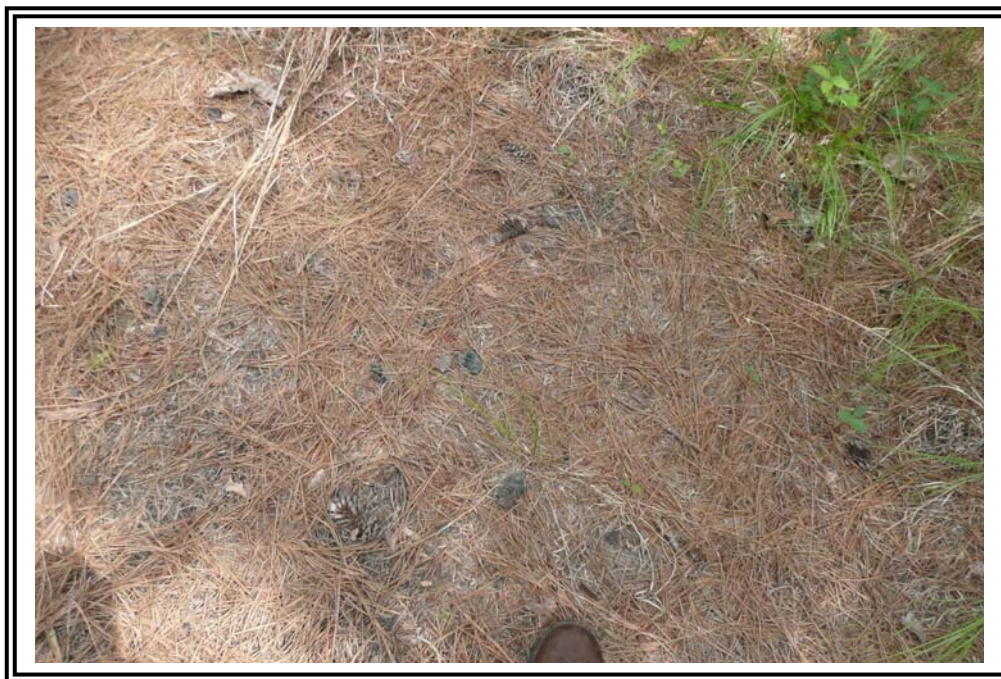
107

Exposed ash at the ground surface within the 1956 Ash Pond.
